FEATHER RIVER RAIL SOCIETY AGENDA REPORT

DATE: March 29, 2003
FROM: Director Vicknair
MEETING: April 3, 2001
ITEM: New Business 1
SUBJECT: Offer to donate TS/WP Bunk Car 0565-H

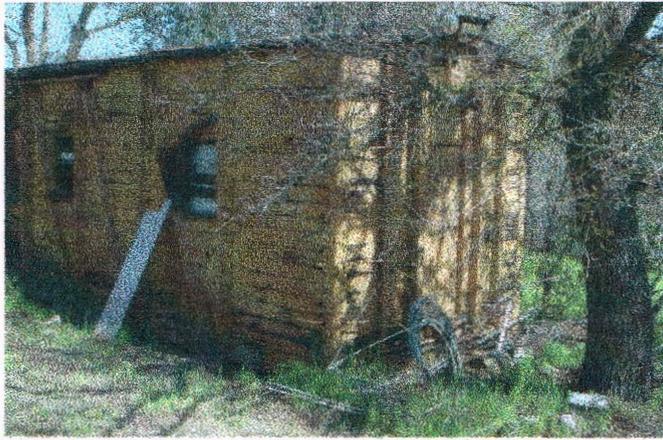
SCREEN TO LEFT OF WINDOW IN PICS

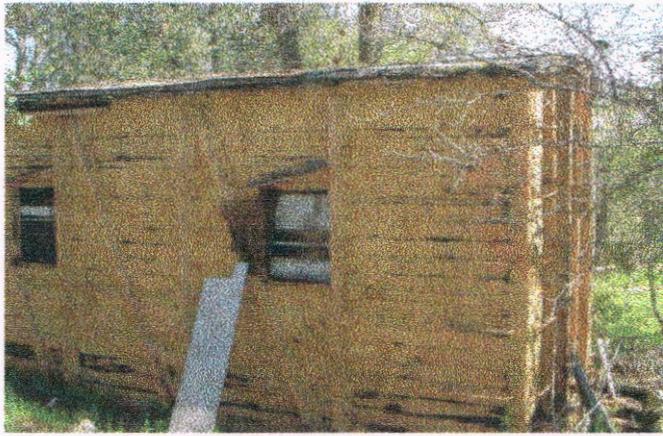
Due to tree encroachment, getting photos was difficult. Both Rick and Tom commented that these photos do not do the car justice and that it is good shape.

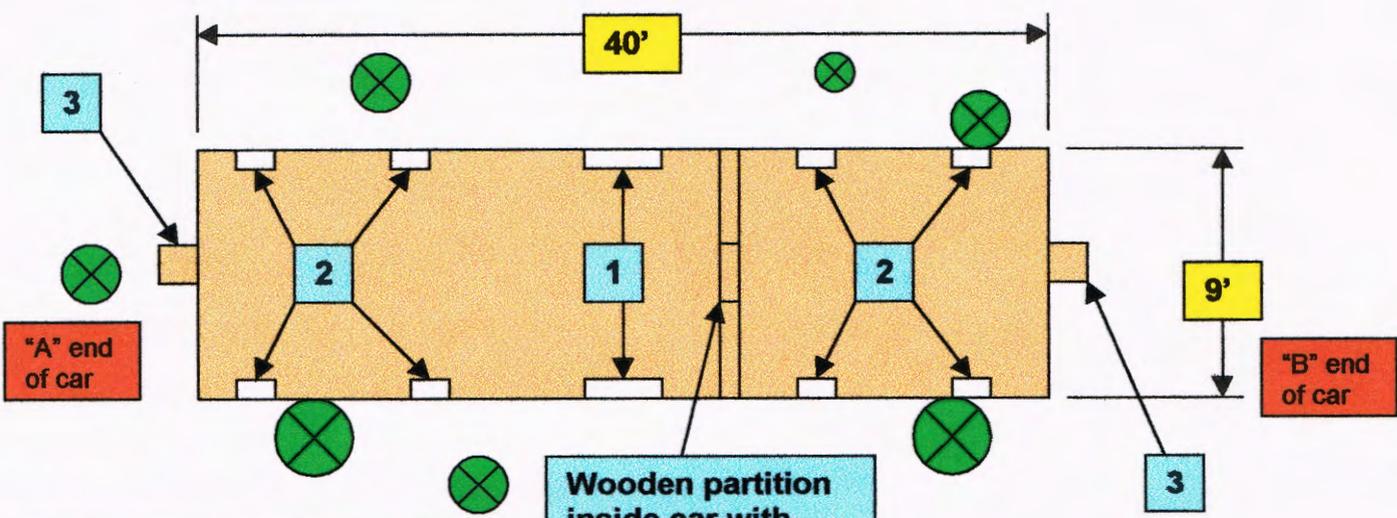
Wooden partition inside car with door in middle, not original

Downhill side of car. Car is on a gentle, sloping dirt hill.

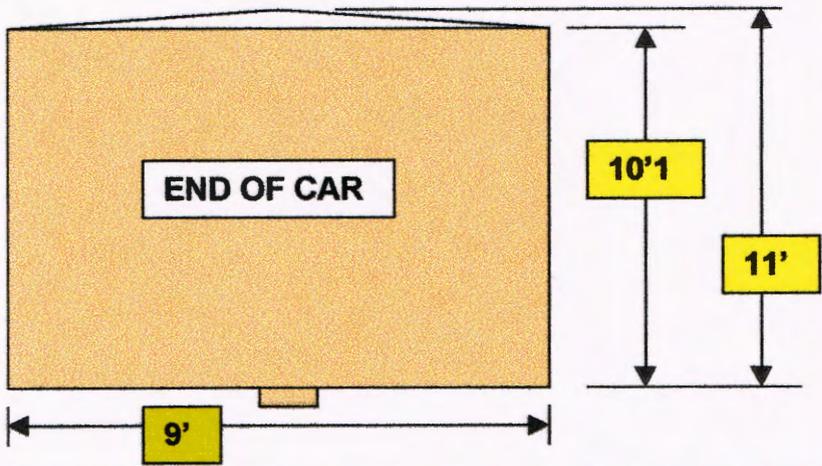
Roof- Original wood with tar paper over it. Roof did leak, but not after the tar paper. No internal damage inside car on roof.

Floor-Original, I think. Floor is not broken thru and is solid.

Interior walls-Very nice condition. Painted light blue (per WP colors). Car still has the WP safety slogan "Be alert-Don't get hurt!" inside.

Exterior walls-Painted in orange paint, but wood is rotted on the outside in some places. Still structurally strong.

Safety appliances: All there and most are tight on car. A couple are loose. Ladders ok.

Metal bracing/car frame: All outside and inside metal bracing is in original, painted shape. Frame is on ground, but apparently in good shape.

Recommendation: This car is in very good structural condition. The inside and outside bracing is very straight, not bent or rusted. The center sill is on the ground, so a closer inspection can be done when car is loaded for transport. Interior just needs to be cleaned and polished. Outside wood needs some repair, but still strong. Some wood-rot is visible. All safety appliances are still on car and are mostly
