## Motorcar 23 Project Update

### UP 25283 Caboose

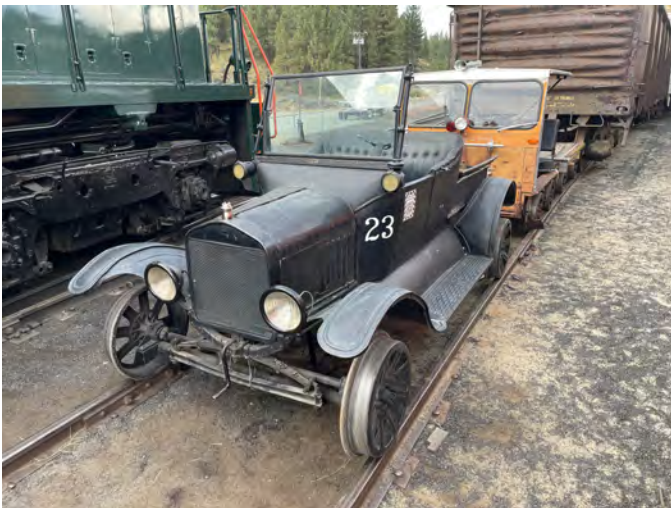
Charlie and I discussed the issues he was seeing with the car. Specifically, the engine overheated shortly after startup and there was a persistent fuel leak beneath the car. After extensive inspections and a few test runs, it was decided an overhaul of the ignition and fuel delivery systems were in order.

The fuel system repairs were relatively simple. The leak was from the fuel bulb, which had previously been modified to have a remote shut-off lever. This lever, when actuated, was rubbing against the bulb causing the shaft assembly to work out of its bore. Since this is a spring held interference fit, it leaked whenever the lever was not perfectly vertical. To resolve this, the fuel bowl was replaced with a stock unit and a new shutoff was installed at the carburetor, a more convenient location for the operator. The existing fuel line was also noted to be run above and too close to the exhaust pipe. A new fuel line was installed with proper routing.

*Keep an eye out for future updates!*  
- Photo by Nick Manos

The ignition system on the Model T appears very unique when compared to more modern automobiles. A key distinction is the use of individual ignition coils for each cylinder which makes engine timing dependent on every coil being in proper tune. Malfunctioning coils always lead to poor operation and overheating. The coils are cased in wood and installed in a coil box that uses wood backers for the sides that make contact with the coils. The coil box normally has a lid to protect the coils, but Motorcar 23's lid was missing and water damage from recent storms had deformed all the coil cases and the coil box,

rendering them unserviceable and unfit for rebuild. A replacement box and lid were acquired, sandblasted, painted and rebuilt using plastic backers in place of the wood, along with all new contacts. Four donor coils were rebuilt with new capacitors, points and shims. The coils were all tuned using an electronically cranked coil tester (ECCT). The ECCT is one of the best methods of coil tuning available, as it allows all coils to be tuned to fire at precisely the same time after activation. This provides for a properly timed and smooth running engine.

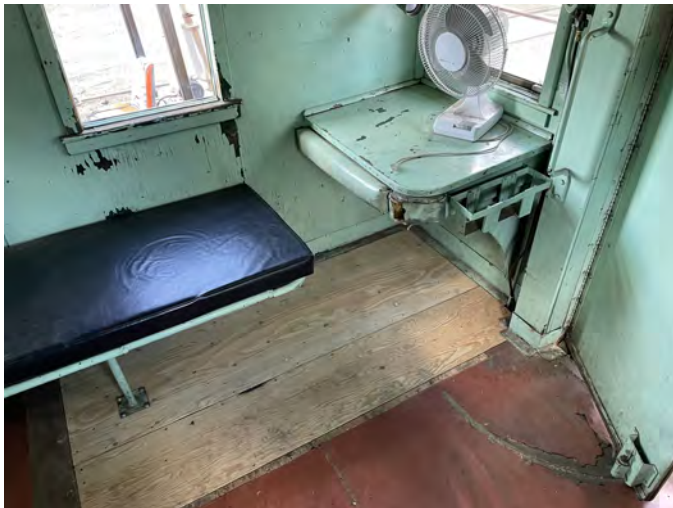
I was assigned three issues to resolve. The floor under the conductor's desk was rotted out and could best be described as a collection of dry rot held together by really old linoleum and top notch glue. The conductor's desk seemed to have suffered repeated abuse as a chair and was separating from the wall it was (sort of) mounted to. Oh, and the ceiling panels were falling down... minor issues like that.

I started with the ceiling. After removing the trim, I was able to have a look at the problem. UP felt it was entirely adequate to hang plywood, upside down, with common box nails. It is

surprising it lasted this long. Setting some screws secured all the panels. Some additional damage repair and new paint to two panels put the ceiling in good order. New trim boards have been milled and painted and will be installed in the coming weeks.
