REPORT OF THE DIRECTOR OF THE BUREAU OF SAFETY IN RE INVESTIGATION OF AN ACCIDENT WHICH OCCURRED ON THE WESTERN PACIFIC RAILROAD AT SUNOL, CALIF., ON NOVEMBER 28, 1930.

December 31, 1930.

Inv. No. 1679
Western Pacific Railroad
Sunol, Calif.
November 28, 1930

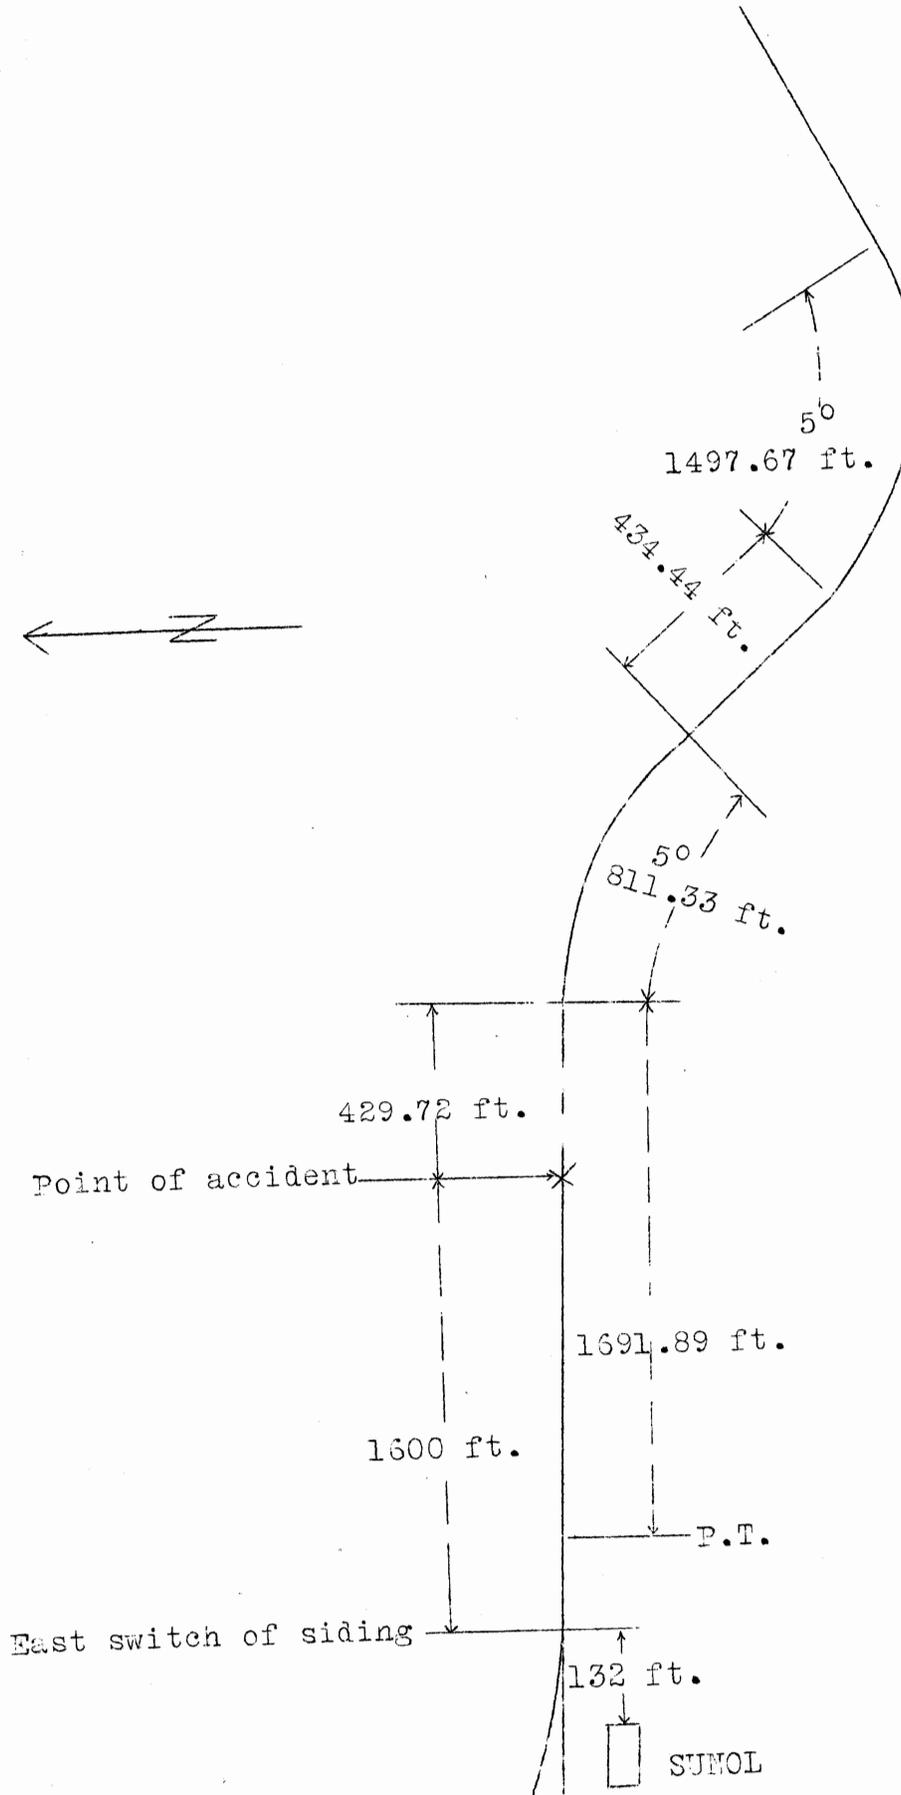
Approaching the point of accident from the east, a view of the markers on a caboose at that point could be had from the fireman's side of an engine for a distance of approximately 2,000 feet, and an entirely unobstructed view could be had from the fireman's side for a distance of 1,015 feet; a direct view could be had from the engineman's side for a distance of approximately 568 feet.
