Engine Tender Snow Plows

By James L. Ehernberger

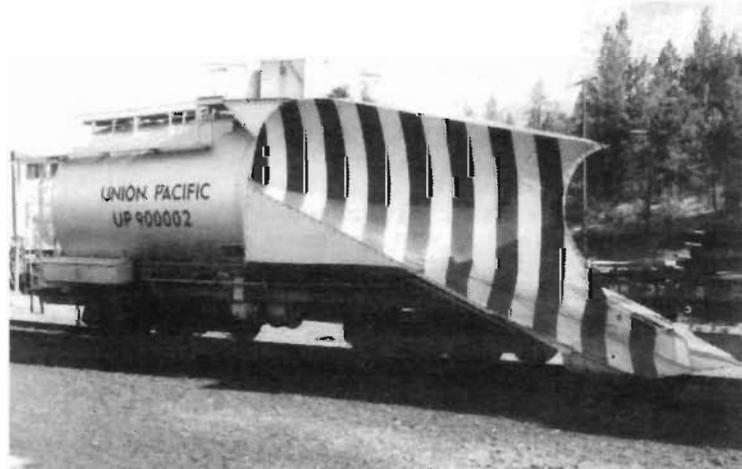
No. 02, single track type, built 09-1949 at Pocatello, ID, Original tender No. 12-C-213 from original engine No. 3562, wedge from 03018 which was originally built 11-1916 as 076 and vacated 02-1949, weight on front truck 114,700, weight on back truck 114,720, total weight 229,420, renumbered 900002 in 12-1959.

Snow Plow UP 900002 shown here at the museum with the side skirts removed from the front truck, and with roller bearings.
