Engine Tender Snow Plows

By James L. Ehernberger

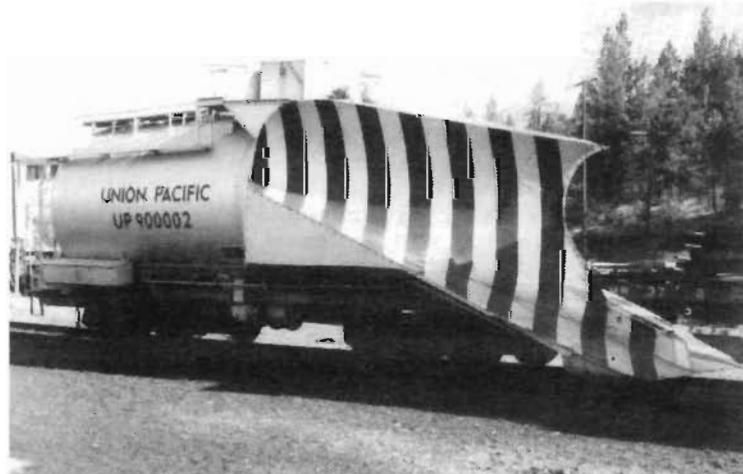
No. 02, single track type, built 09-1949 at Pocatello, ID, Original tender No. 12-C-213 from original engine No. 3562, wedge from 03018 which was originally built 11-1916 as 076 and vacated 02-1949, weight on front truck 114,700, weight on back truck 114,720, total weight 229,420, renumbered 900002 in 12-1959.

Snow Plow UP 900002 shown here at the museum with the side skirts removed from the front truck, and with roller bearings.

Instructions were also issued in the event it was necessary to lift the plow end of the tender due to derailment, i.e., at the front end sill of the tender frame. For this purpose, the side skirt doors of the plow adjacent to the front end sill are removable. Wood blocking should be used where sling cable contacts base of the snow plow.
