Waking a Tired Workhorse: Bringing WP917D into service for 2015

– David Elems (“Fritz”)

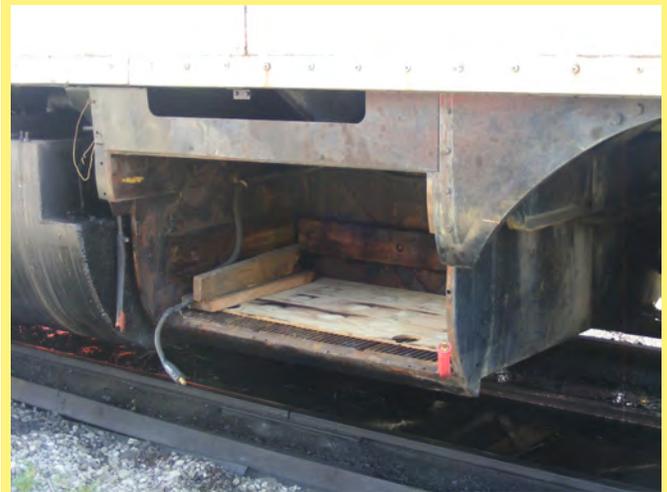
WP 917's right side battery box, prior to cleaning. Regular cleaning helps slow the corrosive effects of battery chemicals on the metal of the locomotive. The wood lining prevents terminals from inadvertently touching the metal body.

With their help 917 was moved over the oil pan, a location more readily accessible by the electric forklift. Within an hour and a half Steve arrived, and work could finally begin on getting the batteries swapped. The batteries were removed and the battery boxes washed out. Clean battery boxes are important!

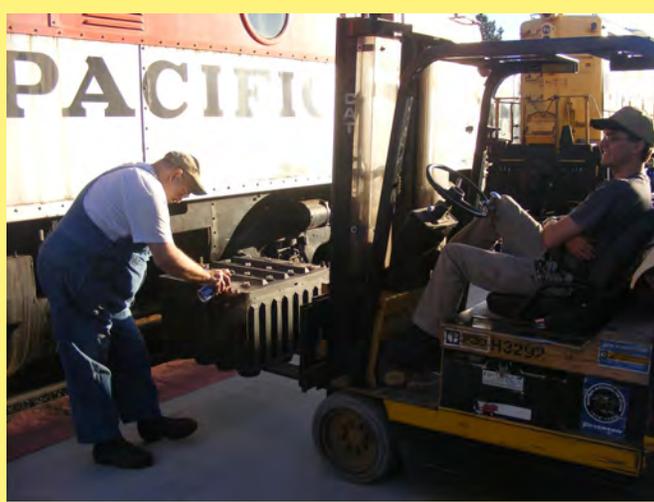
Steve Habeck applies terminal protector after installing the lead connector, while Poindexter waits at the helm of the electric forklift. It's important to remember to use protection.

At this point we had to fire SP2873 back up and pull four rail to get the rotary set over to a 'forklift accessible' location. Once both batteries were removed from the rotary snail, everything was put back on four rail and 917 was spotted at the loading platform alongside three rail. Before placing the batteries into 917 we decided this would be an opportune time to service them, and both batteries had their water levels topped off. We were about to start putting batteries back in 917 when we noticed that the connectors were different; both locomotive and batteries had male connector ends. We utilize welding lead connectors to ease in connection/disconnection of batteries during servicing. Luckily the connectors are not hard to swap, and soon we were back to the task at hand.
