### Steam Work Session September 2019

A short work session was held September 27<sup>th</sup>-29<sup>th</sup> to continue work on the WP 165. Work was focused on mainly working on piping in the cab. Mike Waters lapped an injector valve seat after Roger Stabler cut new seats on the steam valve. We completed an injector and its piping. The firing valve was installed and the manifold body, made by Channing Walker, was installed.

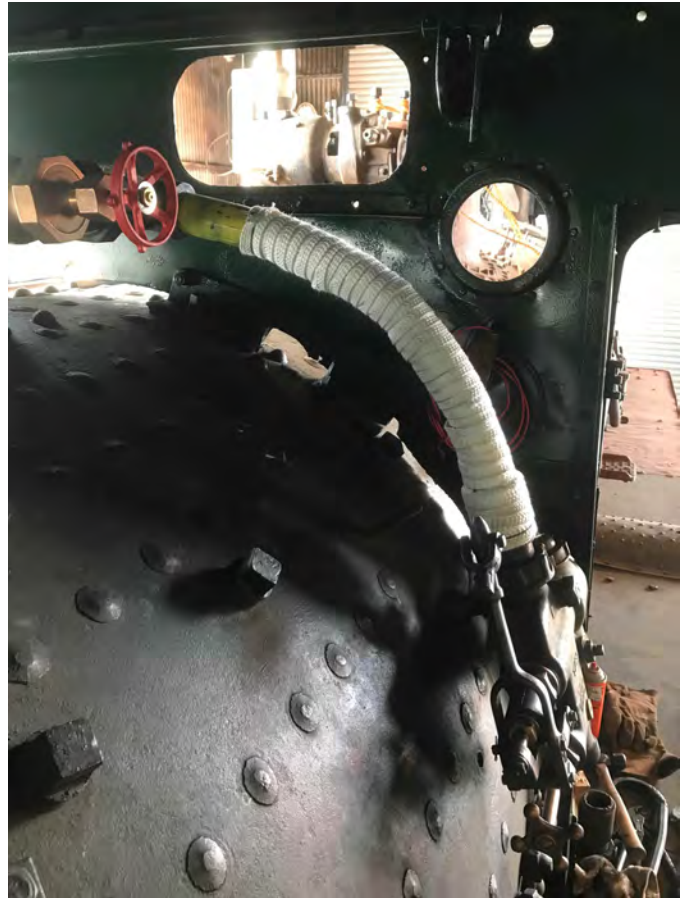
*Firing valve quadrant installed by Channing Walker, Channing also made up a new fireman's manifold body.*

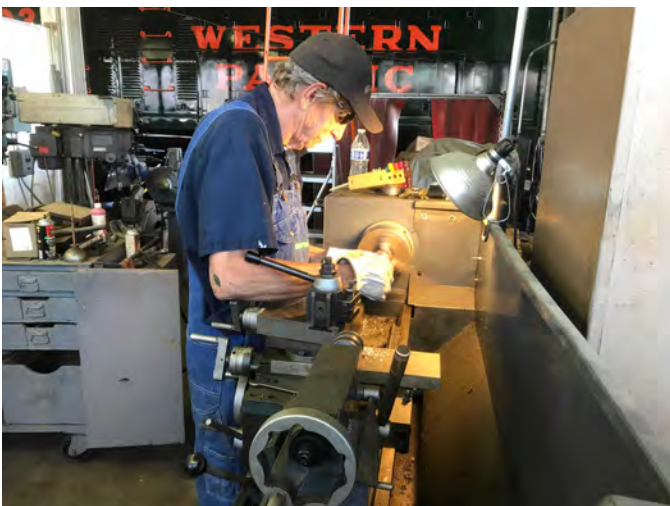
*Mike Waters grinding valve for engineer's injector.*
