**Western Pacific Reefer PFE 55069**

- Eugene Vicknair

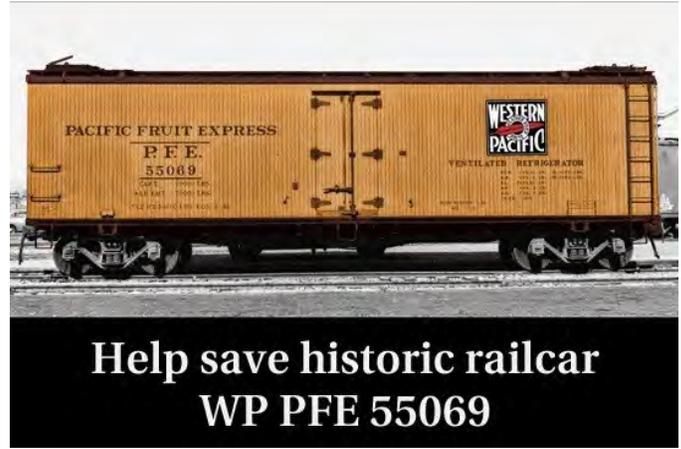
With help from non-member Christopher Kapreilian, I was able to remove the last intact outer ice hatch. Although in poor condition, it can serve as a pattern for new hatches. All inner hatches are present and look to be in reasonably

good condition, although one or two may need to be replaced. Overall, the roof looks in fine shape, although the wood is almost all gone. Only one small area of the sheet metal roof showed rust-through. The rest of the metal and most of the hatch hinges and latches look to be in good shape.

The ice hatches have now been tarped for the winter. In the spring, the plan is to start with repairs on the roof and replacing the missing walkway and outer hatches. In addition, we will stabilize the door that has been used as the only access. Forty years of use have finally caught up with it and it is sagging. Once the roof is done, we will likely move on to replacing the siding, one side at a time, and address the small amount of frame rot found on the side that was exposed to the weather and dirt.

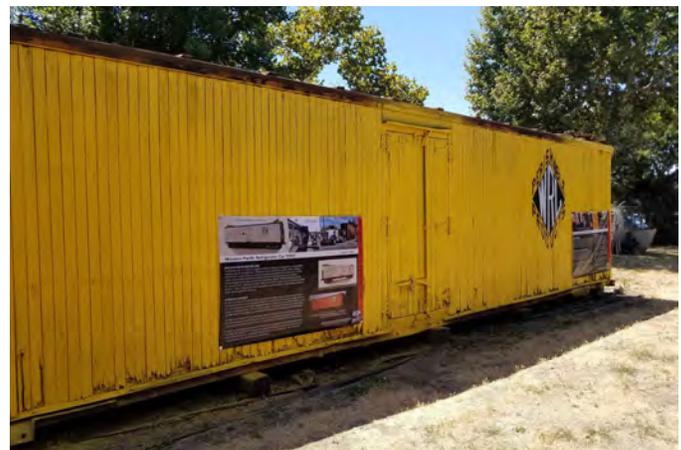
If anyone would like to be notified about work sessions for the WP PFE 55069, please contact me at [info@wplives.org](mailto:info@wplives.org). Work takes place at the California Trolley and Rail Corporation work site adjacent to the Santa Clara County Fairgrounds in south San Jose, right off Monterey Highway.
