INVESTIGATION NO. 2480
THE WESTERN PACIFIC RAILROAD COMPANY
REPORT IN RE ACCIDENT
NEAR MERLIN, CALIF., ON
JANUARY 26, 1941

Accident near Merlin, Calif., on January 26, 1941, caused
by damage to the track, as a result of a rock slide.

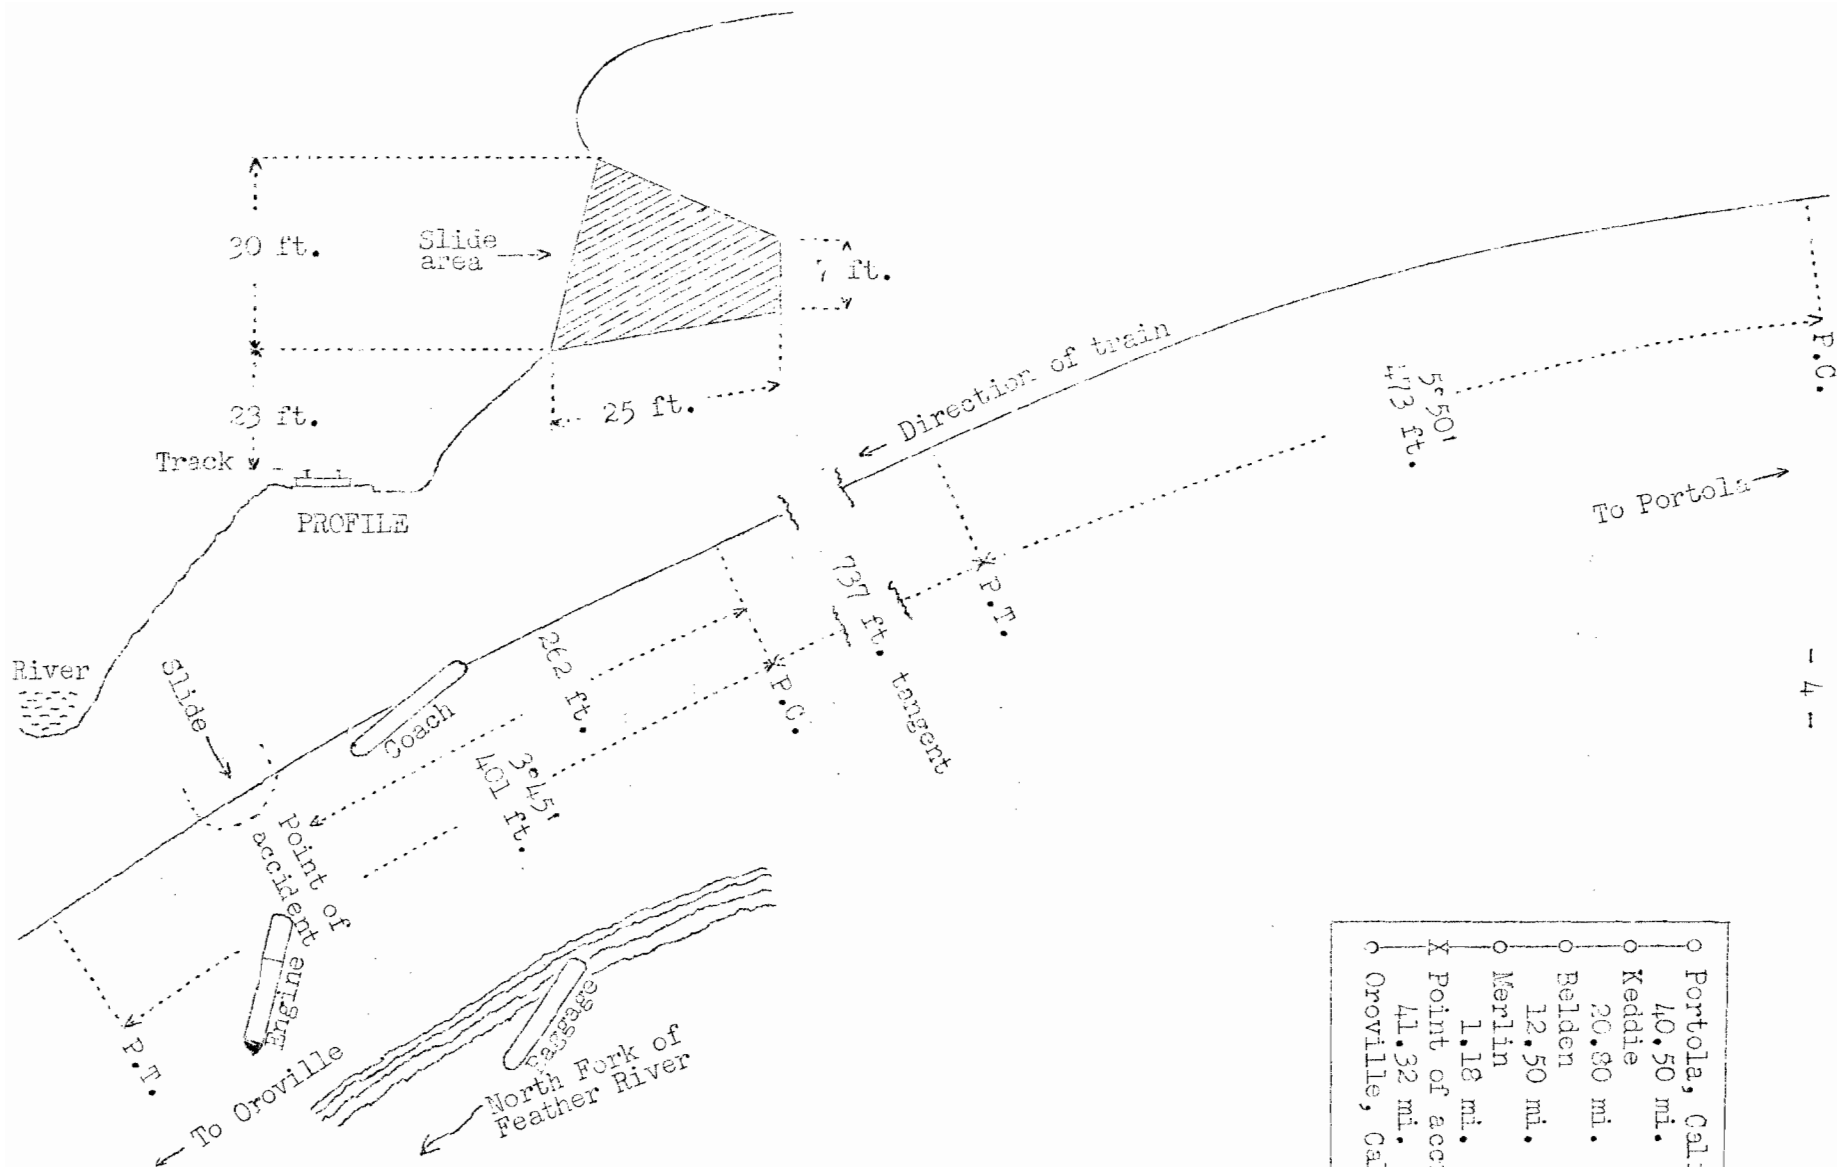
Inv. No. 2480
 Western Pacific Railroad
 Merlin, Calif.
 January 26, 1941

○	Portola, Calif.
○	40.50 mi.
○	Keddie
○	20.80 mi.
○	Belden
○	12.50 mi.
○	Merlin
○	1.18 mi.
X	Point of accident
○	41.32 mi.
○	Oroville, Calif.
