## Inspection Report

### **California Zephyr Dome-Coach "Silver Lodge"**

Chicago Burlington and Quincy 4717

Inspected at TransTexas Rail, San Antonio, TX – September 24, 2004

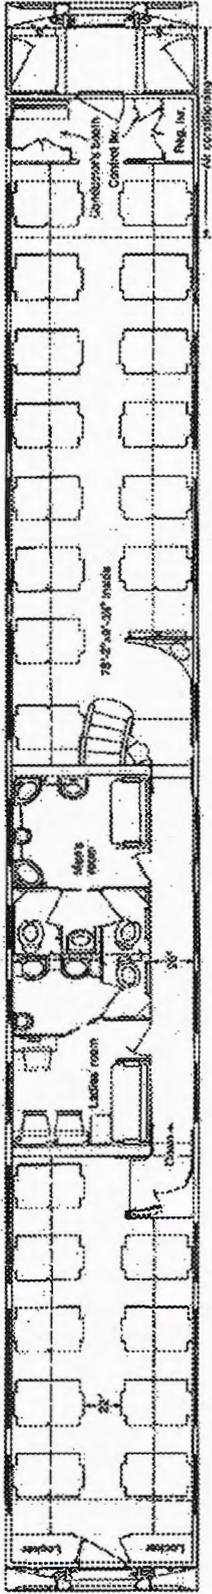
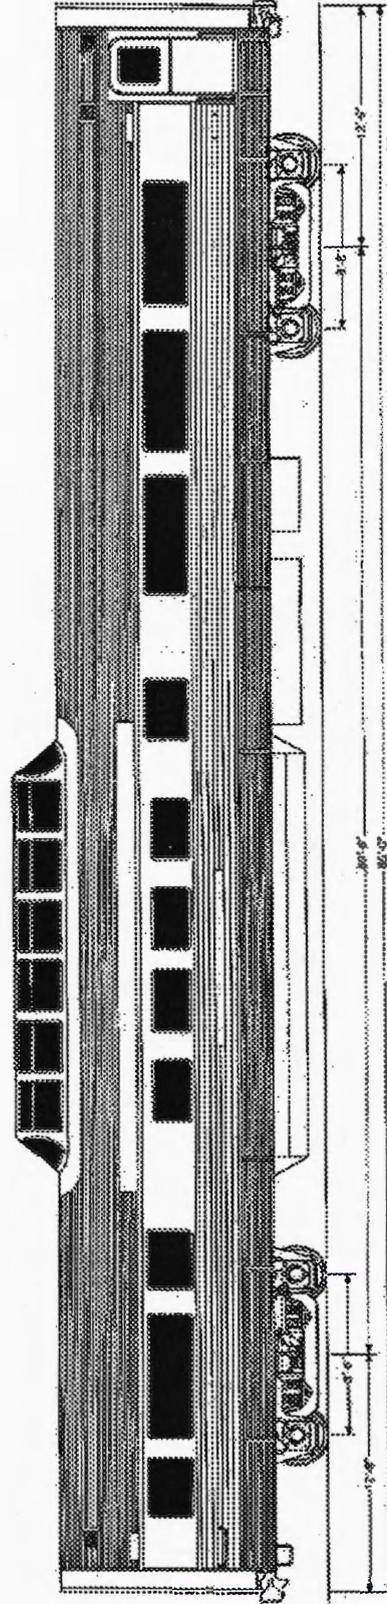
# California Zephyr Dome Chair Coach

Plans not to scale

From Plans originally drawn by Julian Carallier  
Used by permission  
copyright Carstens Publications Inc. 1976, 1990
