INTERSTATE COMMERCE COMMISSION
WASHINGTON

REPORT OF THE DIRECTOR
BUREAU OF SAFETY

ACCIDENT ON THE
WESTERN PACIFIC RAILROAD

INVESTIGATION NO. 2222

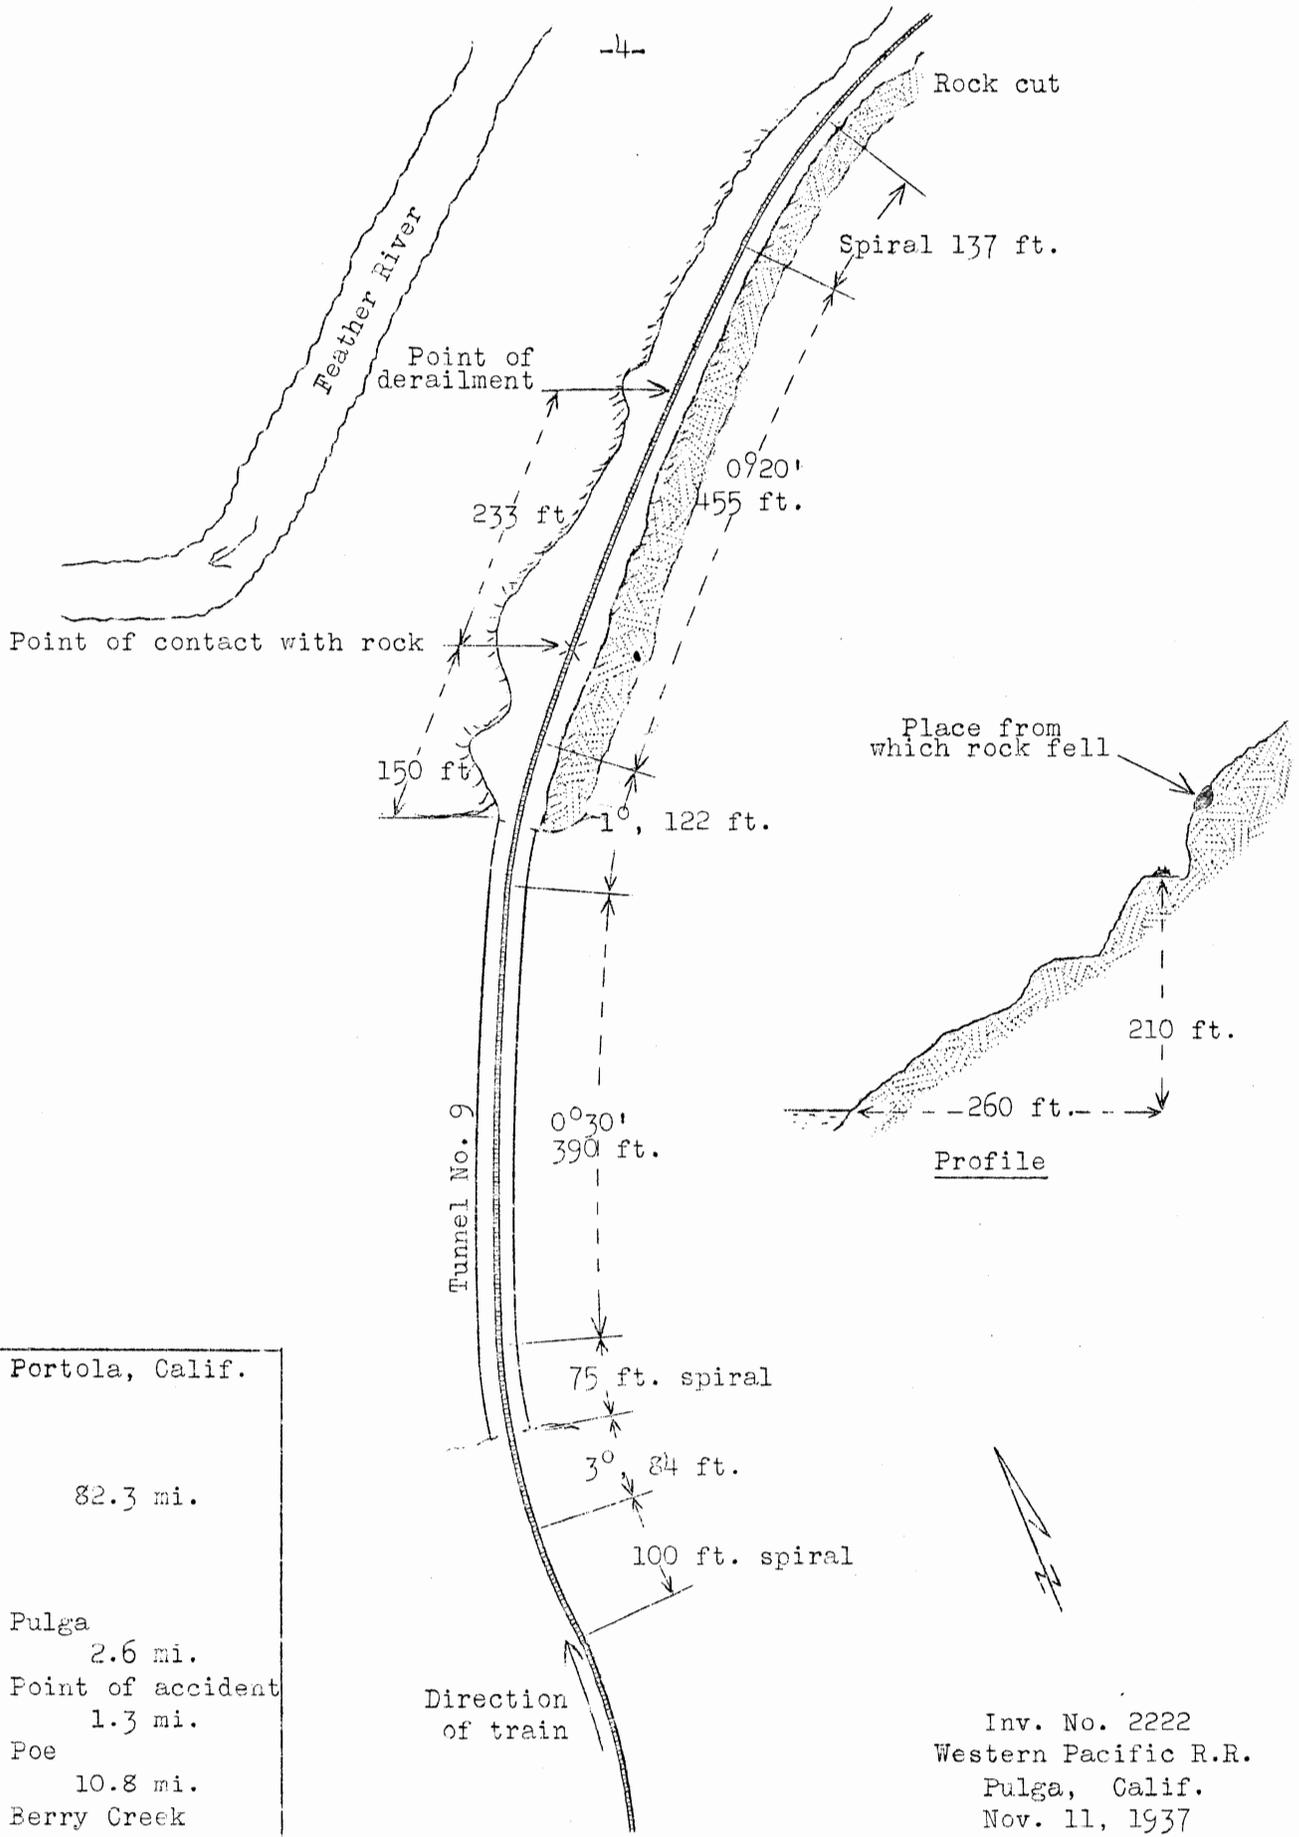
Inv. No. 2222
 Western Pacific R.R.
 Pulga, Calif.
 Nov. 11, 1937

o	Portola, Calif.	
		82.3 mi.
o	Pulga	2.6 mi.
X	Point of accident	1.3 mi.
o	Poe	10.8 mi.
o	Berry Creek	19.3 mi.
o	Droville, Calif.
